## Structural Repair

# 'WRIGHTING' A FRAGILE LANDMARK SAGGING FOR NEARLY 65 YEARS

**OVER WATER** Fallingwater's cantilever, shored since 1997, gets fixed.

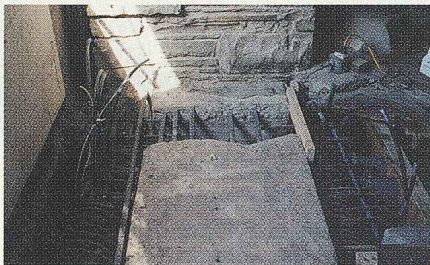
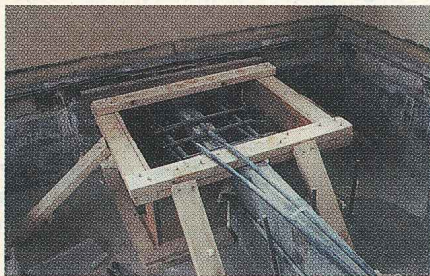
Insufficient reinforcement caused the 15 x 62-ft concrete slab to sag soon after

**INSIDE JOB** Post-tensioning of beams, to arrest up to 7 in. of sagging, raised cantilever less than 1 in.

the Mill Run house, about 70 miles southeast of Pittsburgh, was completed in 1937. The post-tensioning raised the cantilever about ½ to ¾ in., lifting it slightly above the shoring.

On either side of each beam, workers placed a tendon made up of seven, ½-in.-dia. strands housed in a plastic duct that is grouted after tensioning. On each side of the joists, crews placed a tendon made up of a single ½-in.-dia. strand, greased and housed in a plastic sheath.

Tensioning took several days. First, workers tensioned the monostrand tendons, bringing them to a force of some 43 kips. Next came the multistrand tendons, gradually bringing them to a force of about 390 kips each. "We gave the building time to respond slowly since it moved down over 60-plus years," says Matteo.

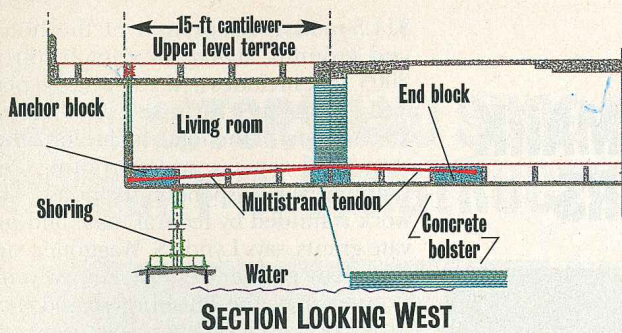
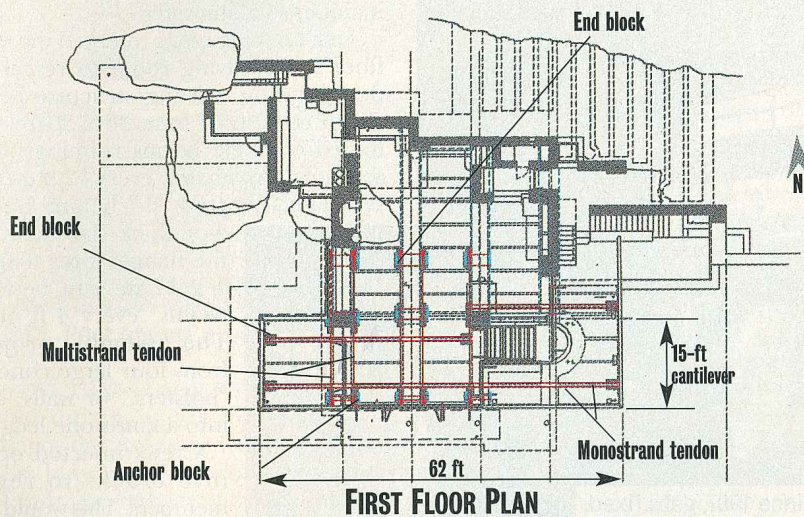
The upper level terrace, which had also sagged, visually functions as an independent cantilever. However, it is structurally tied to the level below by mullions of living room windows. These had become highly overstressed. "We considered reinforcing the upper level with post-tensioning, but had a limited amount of backspan," says Matteo. Instead, the

**TIED TOGETHER**  
Window mullions join upper terrace and living room level to function as one cantilever.

team decided to reinforce the mullions by welding a  $\frac{3}{8}$  x 2 $\frac{1}{2}$ -in. steel plate to each side.
