## Structural Repair

# 'WRIGHTING' A FRAGILE LANDMARK SAGGING FOR NEARLY 65 YEARS

**OVER WATER** Fallingwater's cantilever, shored since 1997, gets fixed.

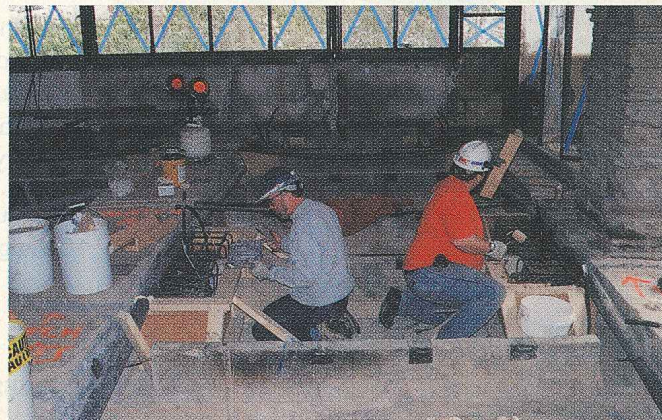
Late last year, crews removed the stone floor in the living room to reveal the deteriorating existing structure below, which consists of four, 36 x 20-in. reinforced concrete beams running north-south, approximately every 12 ft on center. The inverted "T" beams have a 4-in.-thick slab acting as the flange. Joists that are 4 x 17 in. run between beams every 4 ft or so. The assembly projects from four large concrete "bolsters," or walls, built into a sandstone ledge.

Crews injected epoxy into cracks to repair members. This would limit the amount of upward movement associated with the post-tensioning and ensure even distribution of compression through the whole beam, says John Matteo, an associate in the Washington, D.C., office of Robert Silman and Associates, the job's structural engineer.

On either side of each beam, workers placed a tendon made up of seven, ½-in.-dia. strands housed in a plastic duct that is grouted after tensioning. On each side of the joists, crews placed a tendon made up of a single ½-in.-dia. strand, greased and housed in a plastic sheath.
