# PSFS adaptive reuse illustrates preservation tax credits at work

## Practice Matters

By Charles Linn, AIA

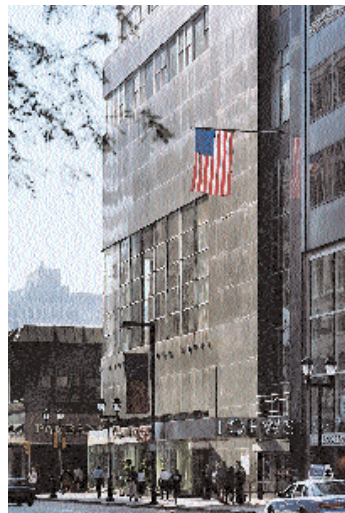
**A new canopy was one of the alterations allowed by the National Park Service so that the PSFS building could function as a hotel.**

realistic about this issue: if they don't permit certain alterations to the building fabric, a project might not proceed at all. For example, the stainless-steel canopy on Market Street is a new addition to the facade. Jones feels that it was allowed by the SHPO and Park Service because it was essential to the operation of the hotel. "They knew that a radical change of occupancy like this could not be made without some changes, and I think they respected that we were taking a responsible attitude toward the project and doing an elaborate restoration."
